Quantitative Investigation of Surface and Subsurface Fatigue Cracks Near Rivets in Riveted Joints Using Acoustic, Electron and Optical Microscopy

**Quantitative Investigation of Surface and Subsurface Fatigue Cracks Near Rivets in
Riveted Joints Using Acoustic, Electron and Optical Microscopy**

A DISSERTATION

DOCTOR OF PHILOSOPHY

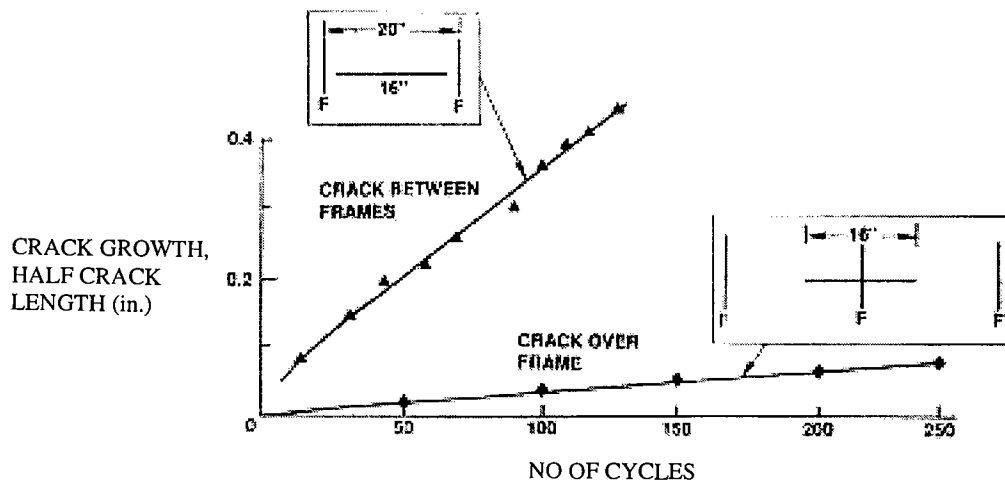
Fig. 2.1. Fatigue test crack growth rate in notched specimens (from Samavedam and Hoadley, 1994, Fracture and Fatigue Strength Evaluation of Multiple Site Damaged Aircraft Fuselages – Curved Panel Testing and Analysis. Final Report, DOT/FAA/CT-94/10, FAA Technical Center, Atlantic City International Airport, NJ, January, 1994, p.57).

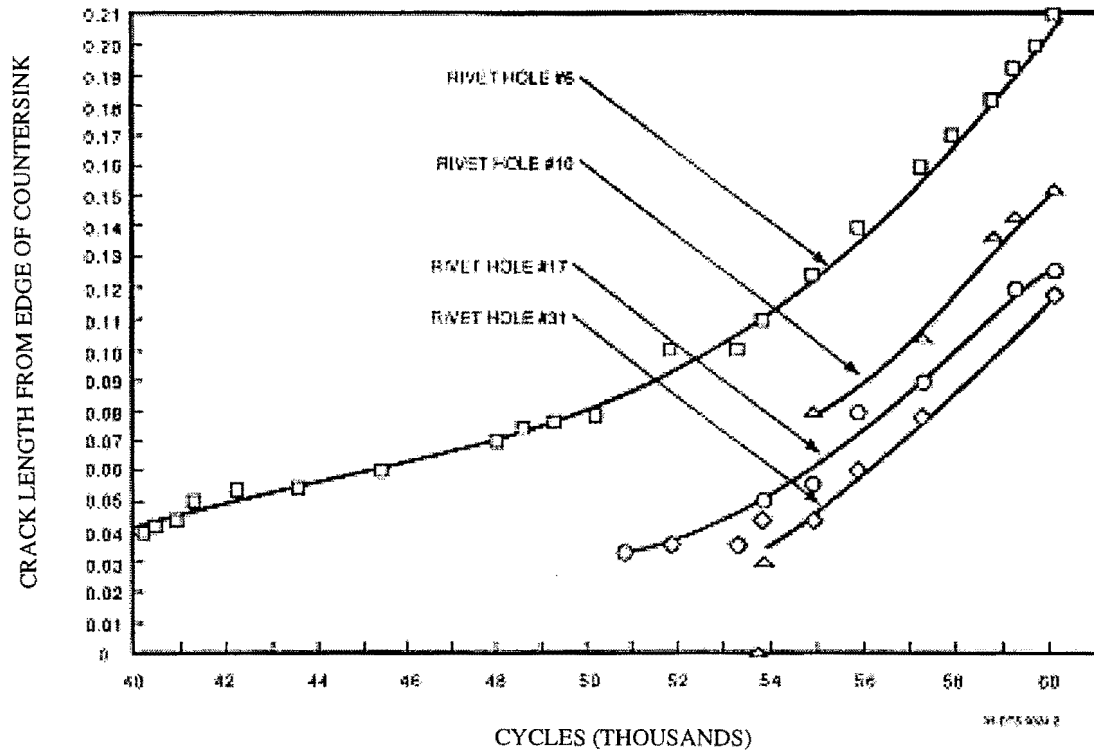
Fig. 2.2. Crack growth data in precracked specimens (from Samavedam and Hoadley, 1994, Fracture and Fatigue Strength Evaluation of Multiple Site Damaged Aircraft Fuselages – Curved Panel Testing and Analysis. Final Report, DOT/FAA/CT-94/10, FAA Technical Center, Atlantic City International Airport, NJ, January, 1994, p. 47).

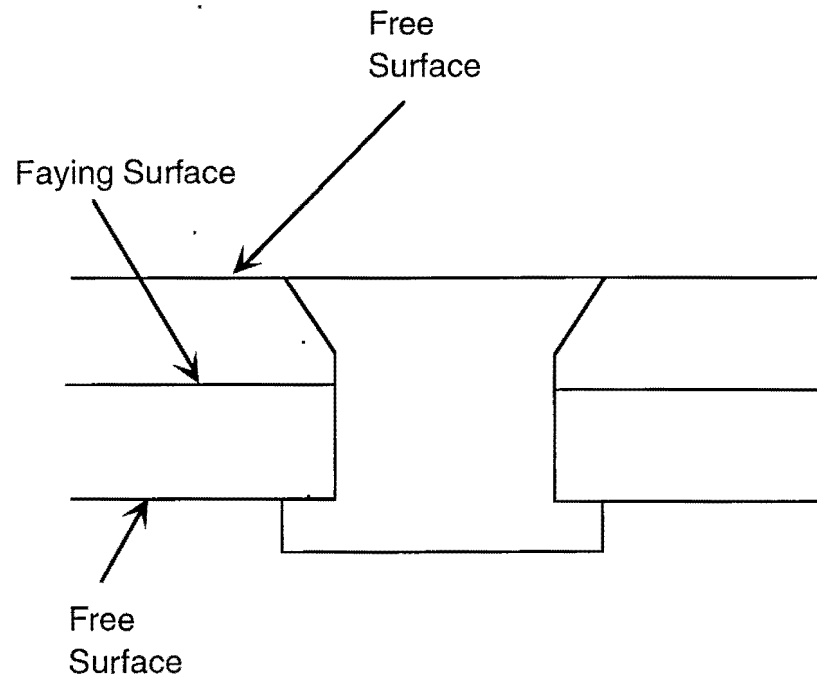
Fig. 2.3. Sketch of cross section of riveted joint

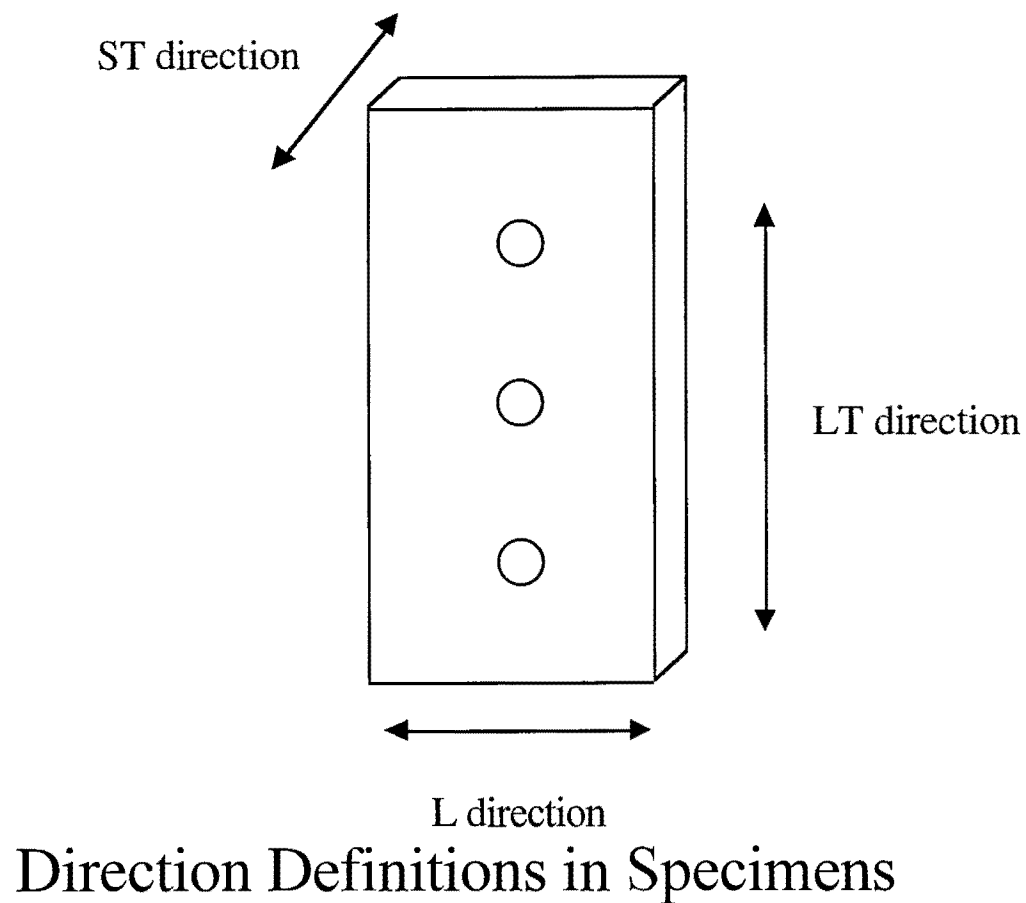
Fig. 3.1. Sketch of the countersunk sheet portion of the test specimen showing the directionality of the grains.

The Alclad 2024 sheet is rolled resulting in elongated grains in the rolling direction, which is called the longitudinal (L) direction. The directionality of the grains in the Alclad 2024-T3 material with respect to the specimens used in the research presented herein is given in Figure 3.1. A representative sample of the microstructure

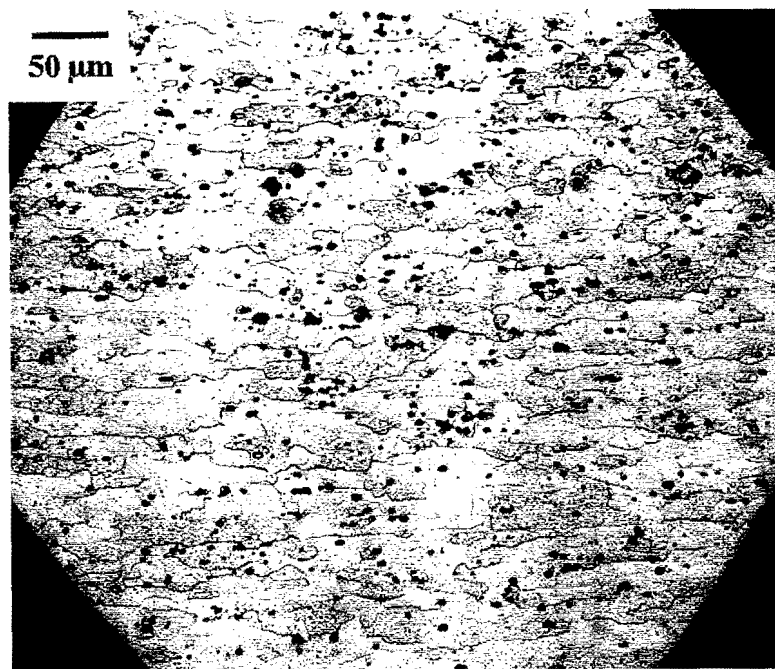
Fig. 3.2. Photomicrograph showing grains in the longitudinal (L) direction

in the longitudinal direction can be seen in Figure 3.2 and of the microstructure in the short transverse (ST) direction in Figure 3.3. The white phase is CuAl_2 , the gray phase is either CuMgAl_2 or $\text{Cu}_2\text{Mg}_2\text{Al}_5$ and the dark particles are CuMgAl_2 , $\text{Cu}_2\text{MnAl}_{20}$ and Cu_2FeAl_7 . [Aluminum, 1993] These are constituent particles. The precipitates and dispersoids are not seen at this magnification.

Representative samples of the microstructure of the 2524-T3 material in the longitudinal direction and the short transverse direction are seen in Figures 4.4 and 4.5 respectively. The number of inclusions is less in the 2524-T3 material than in the 2024-T3 material (see Figures 3.2 and 3.3); hence, there are less initiation sites for fatigue cracks in the 2524-T3 material. Inclusions nucleate cracks and the cracks will hop to other inclusions; consequently, it is expected that the 2524-T3 material will nucleate cracks at a greater number of fatigue cycles than the 2024-T3 material.

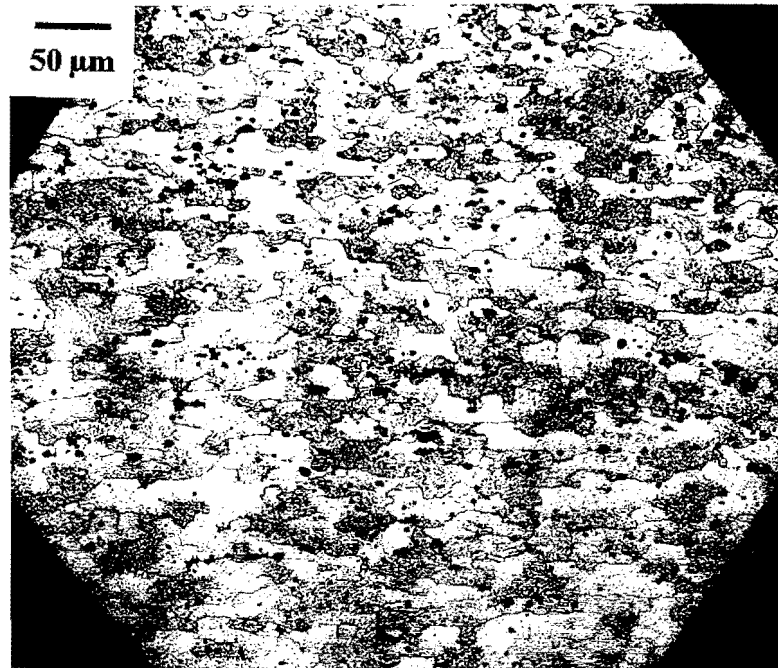
Fig. 3.3. Photomicrograph showing grains in the short transverse (ST) direction

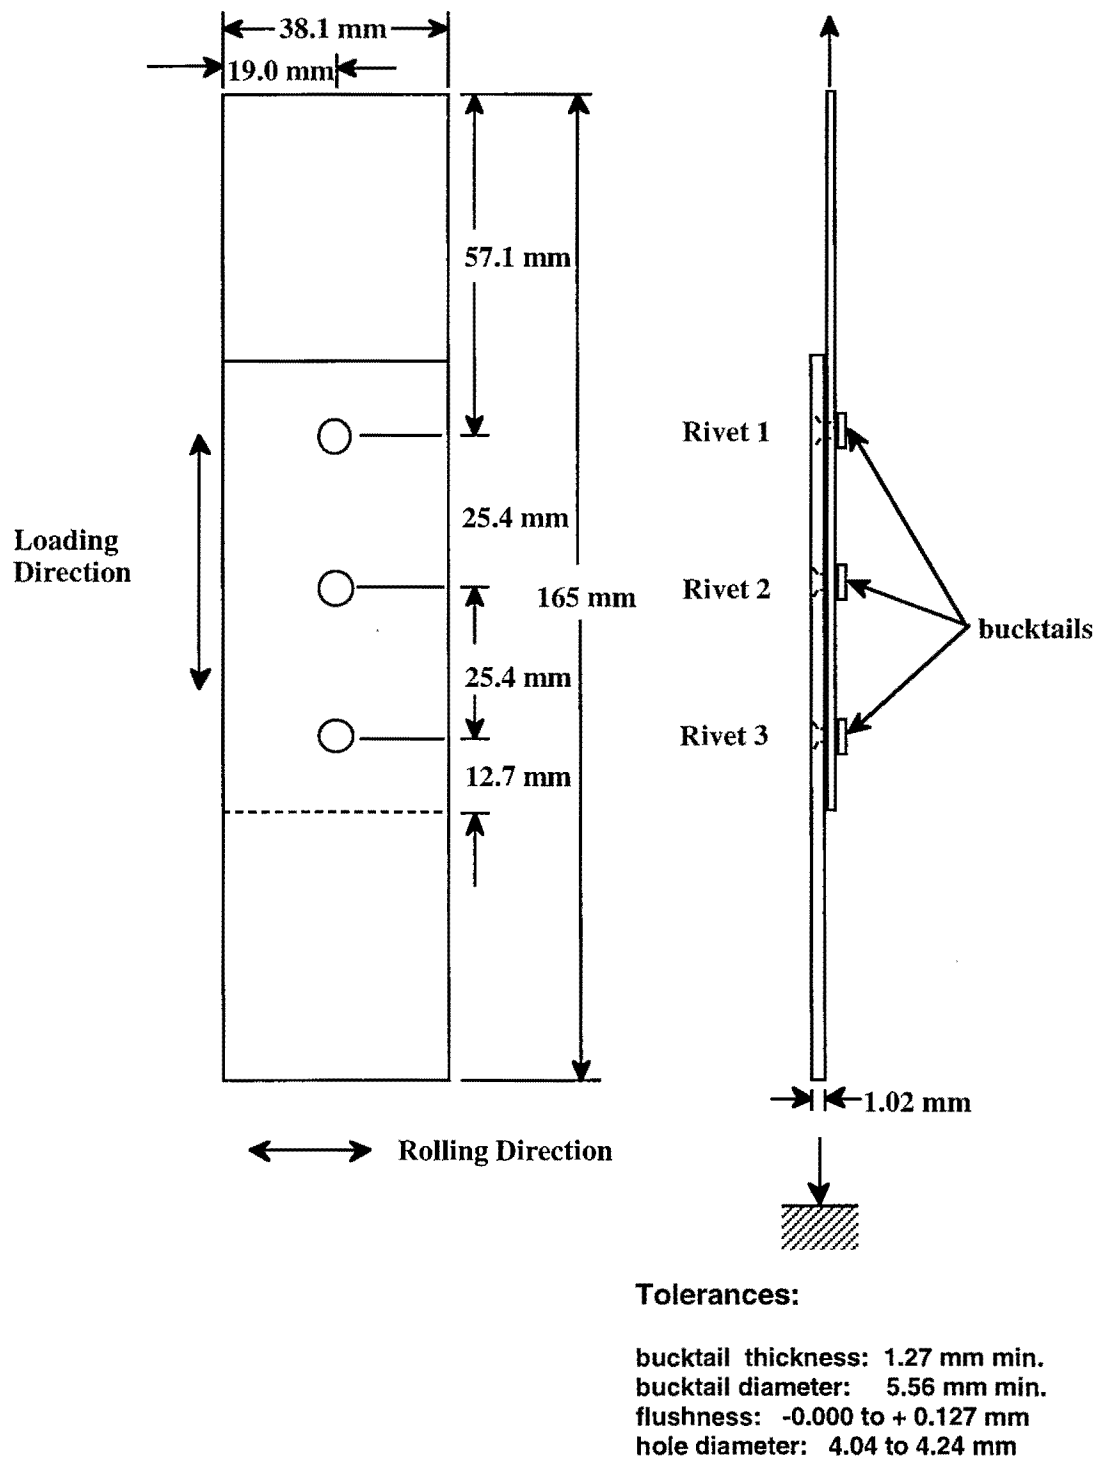
Fig. 3.4. a) Drawing of three rivet assembled specimen

thickness. It was found that higher stresses made the occurrence of uniform multi-site damage (MSD) more likely. MSD almost always occurs in the critical row (Rivet 3 as shown in Figure 3.4) of rivets with cracks sometimes occurring in the second row of rivets. In Mayville and Sigelmann's investigation, the crack growth rate was found to be fairly constant for cracks up to 0.25 inches. This was determined by analysis of striation spacings on an actual aircraft. Fawaz (1997) also performed scanning electron microscope (SEM) fractographic examination for the purpose of obtaining crack growth data in riveted lap joints. This was accomplished by applying marker loads at intervals during the fatigue cycling. It was found that after about 80 percent of the life, cracks would break the surface of open hole specimens, while after about 70 percent of the life, cracks would break the surface of bonded (no rivets) lap joints. For an asymmetric riveted lap joint loaded to 75 MPa, small MSD cracks grew at about $2 \times 10^{-3} \mu\text{m}/\text{cycle}$. Crack fronts were oblique elliptical until final fast fracture when they became slanted.

Lap joint specimens were assembled from two pieces of Alclad 2024-T3 aluminum alloy sheets, one piece with countersunk rivet holes and one piece with straight drilled holes, using 2017-T4 aluminum alloy flat head rivets. The specimen geometry and dimensions are given in Figures 3.4a and 3.4b. The specimens for the comparison of Alclad 2024-T3 and Alclad 2524-T3 were fabricated in the same manner as other specimens with sheet material of Alclad 2024-T3. The sheet material for the comparison tests was 1.27 mm thick while that for all of the other tests was 1.02 mm thick.

The lap joint specimen gives rise to bending due to the asymmetric loading: the loads being transferred through the upper and lower plates are offset. Because of this bending moment, Rivets 1 and 3 (Figure 3.4a) experience a larger load than Rivet 2. Also, due to load bypass, the plates are more heavily loaded at Rivet 3 in the top plate and Rivet 1 in the bottom plate. Müller (1995) calculated the load transmission to be 37.5% of the applied load while Fawaz (1997) gave a conservative estimate of 35%.

not always at) the rivet head of Rivet 3 identified in Figure 3.4a. Rivet 3 is in the location that would be called the critical row of rivets in an assembly of rivets in aircraft outer skins.

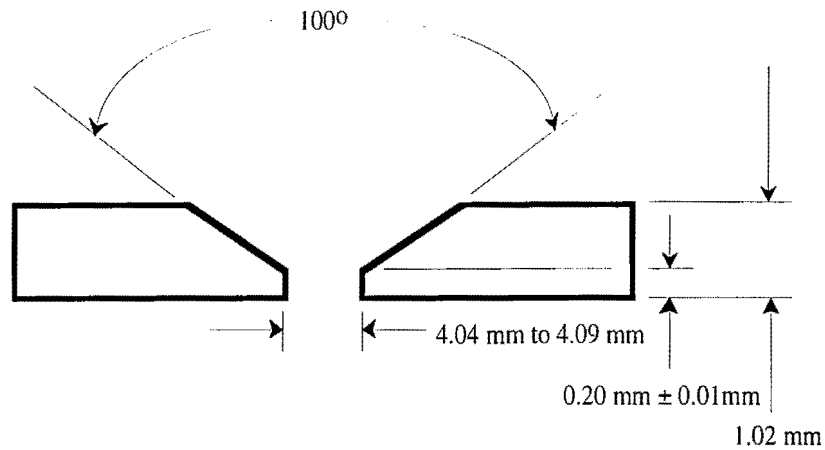
Fig. 3.4. b) Drawing of countersunk rivet hole

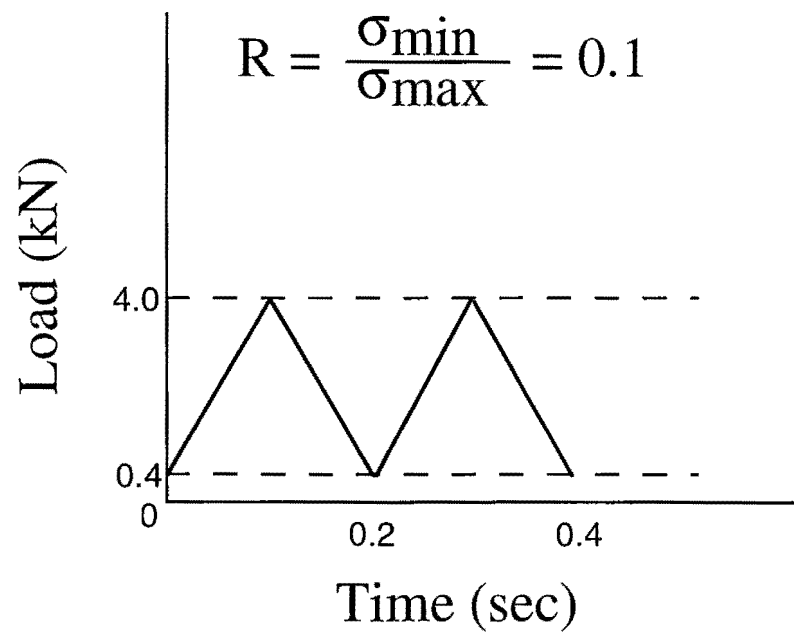
Details of Fatigue Test Loading

Fig. 3.5. Sketch of saw tooth wave used in fatigue tests

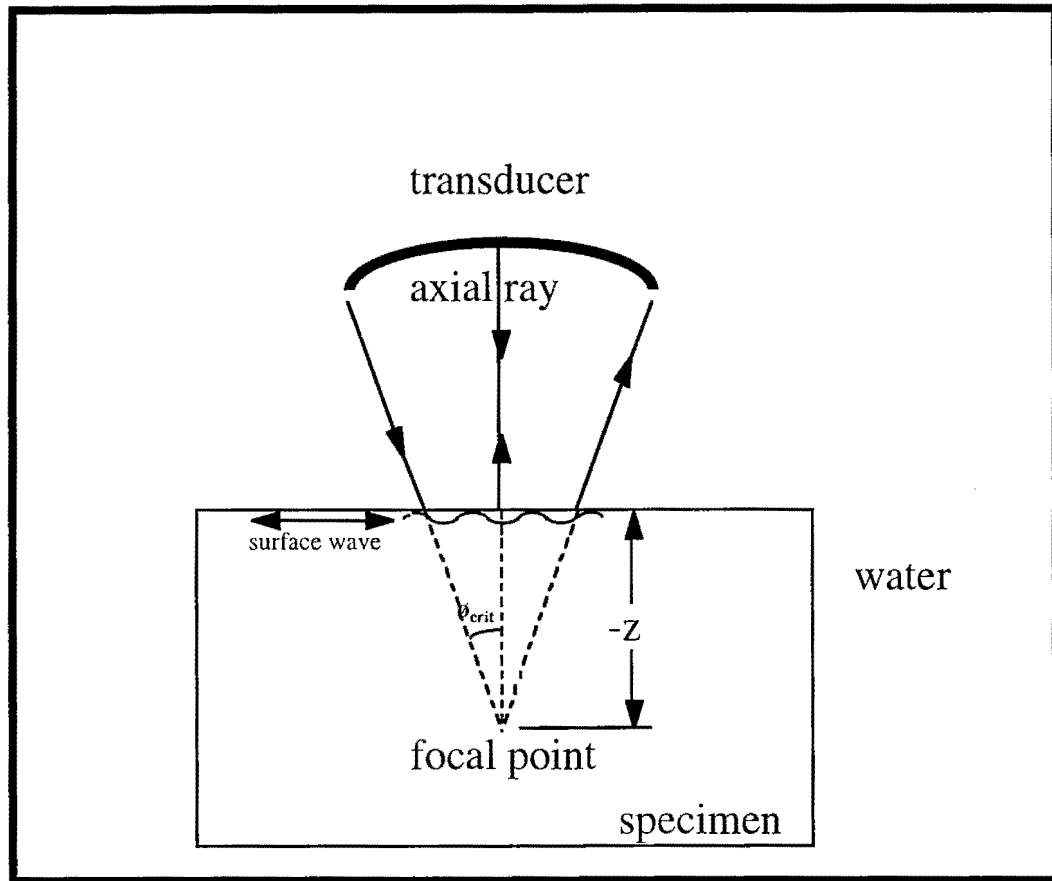
Fig. 3.7. Sketch of acoustic wave generation in a focused transducer

The focused transducer used with the acoustic microscope has a narrow spot in the center of the spherical lens surface, which generates longitudinal waves at normal incidence. It also has a narrow ring near the edge of the sphere, which generates leaky surface waves at the critical angle as shown in Figure 3.7. Other positions on the spherical lens surface generate rays that are reflected at angles that either miss the transducer or hit it obliquely so that this response does not contribute much to the signal. The responses from both longitudinal and leaky surface waves are obtained by defocusing (i.e., moving the transducer closer to the surface of the object than the focal point--see Figure 3.7). As the transducer is moved closer to the surface of the specimen, the specular reflection from the center of the sphere and the leaky surface acoustic waves from the edge of the sphere interfere with each other destructively and constructively in cycles. [Quate, 1985; Tsai and Lee, 1987; Briggs, 1992] Even if the transducer is extremely defocused, the resolution is not affected much, because the vast majority of the energy is localized at the center. [Briggs, 1992] In the research described herein, the transducer was defocused for maximum constructive interference between the longitudinal and leaky surface waves.

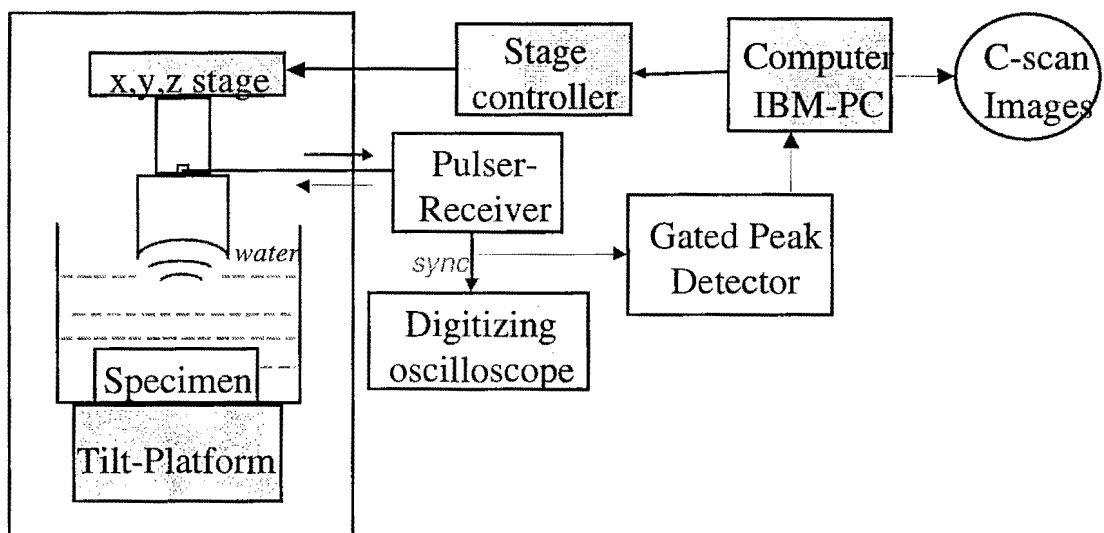
Fig. 3.8. Diagram of setup for scanning acoustic microscope

A focused transducer with a center frequency of ca 50 MHz was used in conjunction with a Panametrics Hyscan system. A block diagram of the scanning acoustic microscope is shown in Figure 3.8. The specimens were submerged in a tap water tank for examination. The focused transducer, made of single-crystal sapphire, was attached to an automated computer-controlled x, y, z stage and was excited by a Panametrics Pulser-Receiver (Model 5601A/ST) to generate ultrasonic waves. The

focused beam was reflected by the specimen and returned to the transducer that also acted as a receiver. When one transducer is used to both transmit and receive the signal, this is commonly called the pitch-catch method. This circumvents the problem of aligning two transducers. The transducer is made of piezoelectric ZnO sandwiched between layers of gold; the lens is made of single-crystal sapphire or silicon, both of which have high velocities of sound as compared to the water couplant. [Wickramasinghe, 1983; Quate et al., 1979] The attenuation of acoustic waves is small in single-crystal sapphire and silicon, another reason for selecting these for the lens. [Briggs, 1992] The transducer output signals, digitized by a Tektronix TDS-540 four channel digitizing oscilloscope and processed by a Panametrics Gated Peak Detector (Model 5608) were finally acquired by a personal computer to produce a C-scan image.

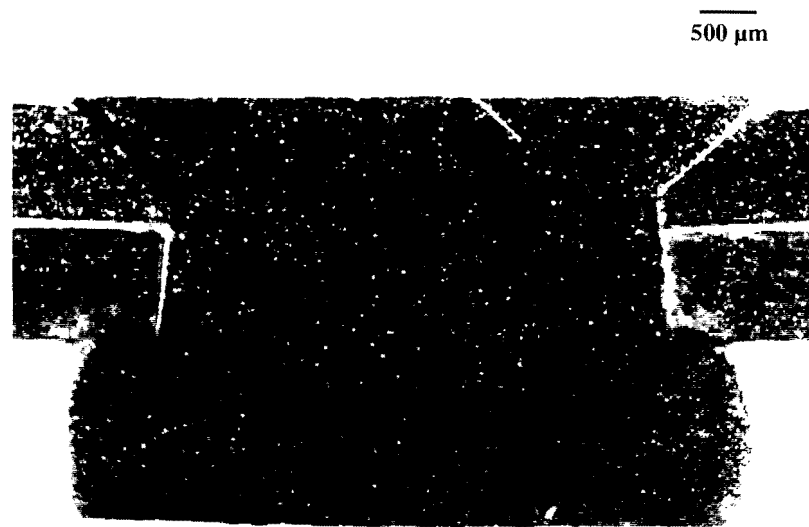
Fig. 4.1. Cross section of unfatigued riveted joint through the middle of the rivet

A cross section of an unfatigued riveted joint through the center of the rivet is shown in Figure 4.1. Two observations are pointed out in the photomicrographs taken of this cross section. First, the soft aluminum cladding has been pushed away from the sheet material near the rivet hole during the formation of the bucktail as shown by the arrow in Figure 4.2. The bucktail is at the bottom of the figure. This is probably not a cause of fatigue crack initiation. Secondly, a small lap in the cladding material on the

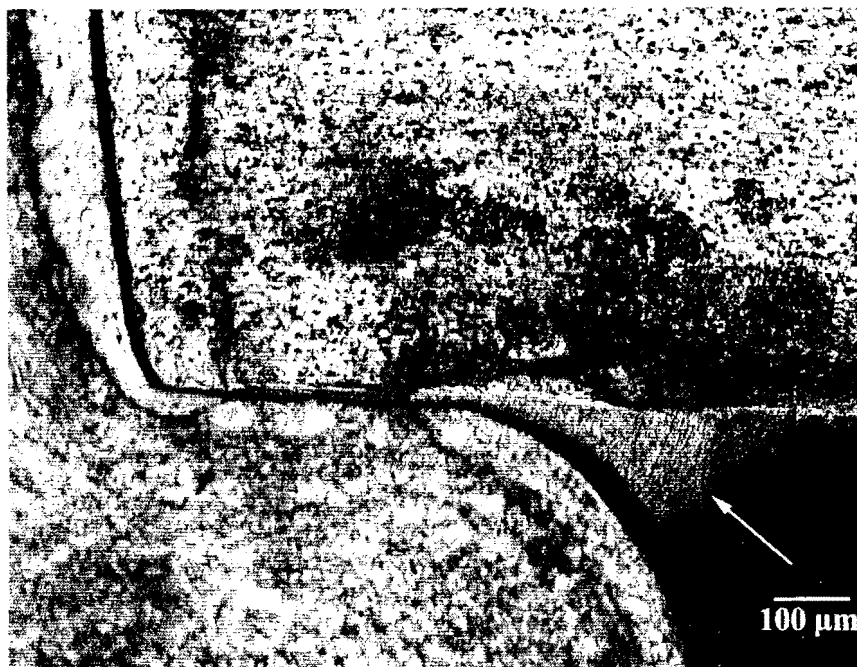
Fig. 4.2. Photomicrograph of riveted specimen showing the aluminum cladding near the rivet hole on the fayed surface that has been pushed away from the sheet material

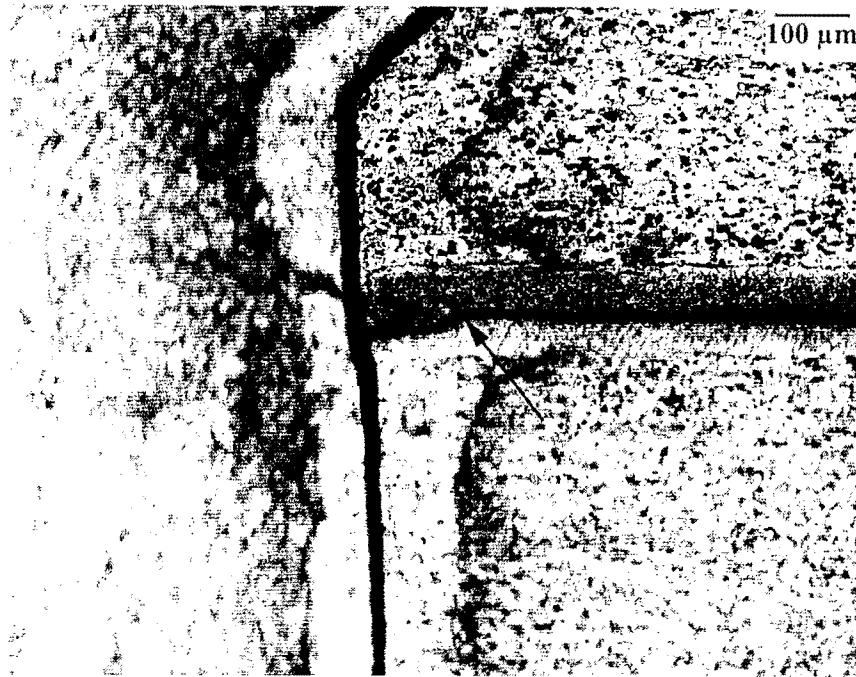
Fig. 4.3. Photomicrograph illustrating defect in cladding material on the fayed surface near the knife edge of the rivet hole

fayed surface is seen near the rivet shank a short distance from the knife edge as shown in Figure 4.3. A lap is a defect in the material (the material folds over on itself). This occurs when the material is being compressed during the riveting process. This frequently occurs during test trials of new forging dies. This is a possible site of fatigue crack initiation as this location will be very sensitive to stress raisers such as those caused by fretting debris. Cracks or irregularities in the cladding material will act as stress raisers and may result in crack nucleation in the substrate. [Hoeppepner et al., 1994]

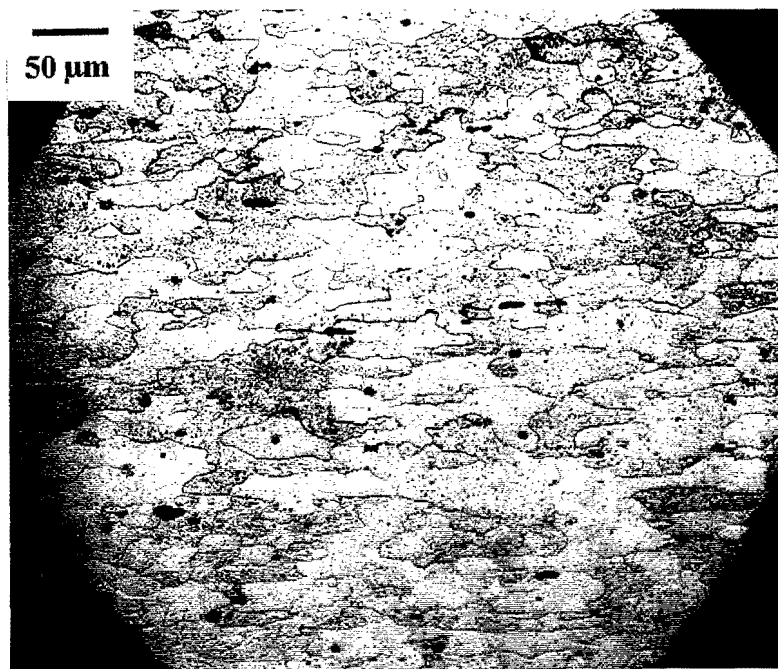
Fig. 4.4. Photomicrograph showing grains in the longitudinal (L) direction in 2524-T3 material

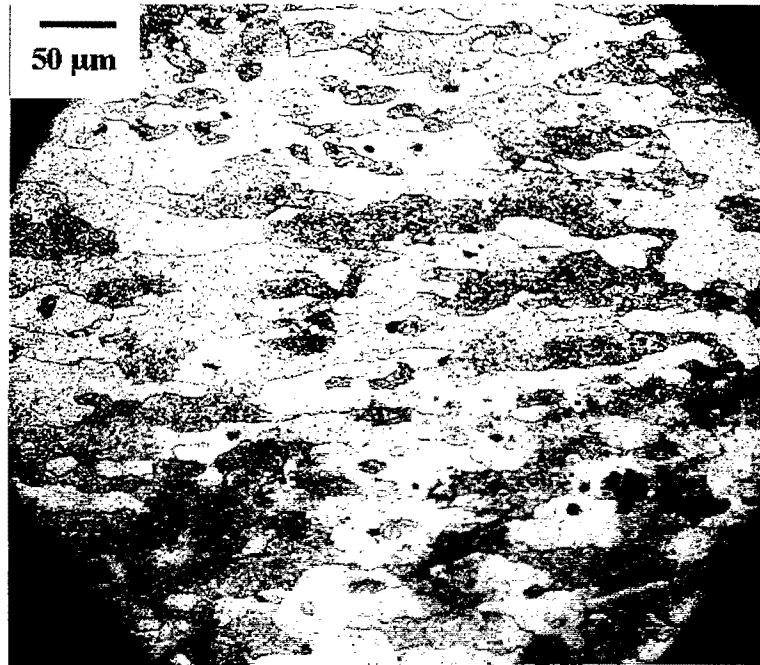
Fig. 4.5. Photomicrograph showing grains in the short transverse (ST) direction in 2524-T3 material

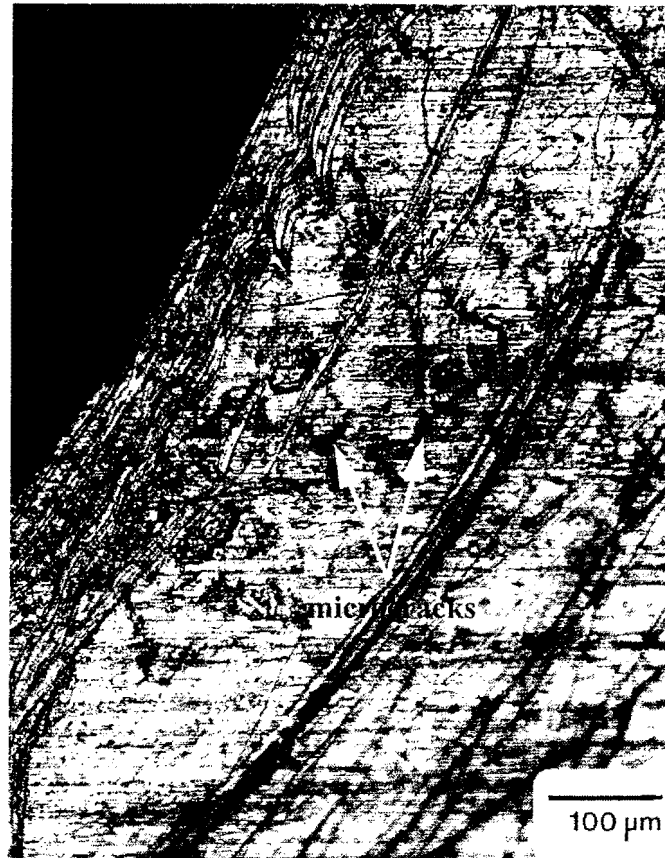
Fig. 4.6. Optical photomicrograph showing the rumpled region near the rivet head prior to the emergence of a propagating radial crack. Two microcracks are pointed out with arrows. (215,000 cycles)

With the optical microscope, the first indication of fatigue damage on the outer surface of the chamfered panel of the specimens, as already noted, was microcracks and strain markings, caused by the plastic deformation associated with the growing subsurface crack. A typical example of the rumpled region is shown in the already referred to photomicrograph in Figure 4.6. Thus a significant crack exists before evidence of damage can be seen optically. This surface rumpling appeared near (but

Since direct optical examination of subsurface fatigue cracks and hidden surfaces cannot be made, the scanning acoustic microscope (SAM) in the C-scan mode was used for this purpose. A C-scan image of the same specimen as shown in the photomicrograph in Figure 4.6 is shown in Figure 4.9. The black region in the center of the C-scan is the area of the rivet head and indicates a total loss of the signal that is returned to the transducer after it has traveled through the specimen. The back surface of the reflected signal from the countersunk panel is gated and explains the loss of signal at the rivet head as there is no surface in this area for a reflected signal. Subsurface cracks on both sides of the rivet head are clearly shown. The orientation of the crack shown in Figure 4.9 has been referred to as the “eyebrow” orientation and was characteristic of all fatigue cracks that formed in the specimens studied at this maximum nominal stress (103 MPa) and R-ratio of 0.1. Such cracks start off propagating at an angle of ca 20° to the stress axis normal but turn to normal to the stress axis as they become longer and approach the normal diametral direction of the rivet eventually becoming mode I cracks (Stage II cracks in Forsyth’s nomenclature). This is indicated in Figure 4.10 where the left side crack is almost normal to the stress direction.

The length of the rumpled region in the photomicrograph, Figure 4.6, is ca. 0.8 mm whereas; the length of the eyebrow crack on the left in the C-scan image is longer, ca. 1.3 mm, Figure 4.9. While microcracks are seen optically only on the surface on one side of the rivet, cracks are shown on both sides of the rivet in the C-scan image. The shorter subsurface crack on the right side of this rivet in Figure 4.9 is ca 0.2 mm long. In this instance the subsurface radial crack was seen before any rumpling (shear bands and microcracks) was seen on the surface using an optical microscope. This is further evidence that the subsurface radial crack did not arise from the surface rumpling even though the latter indicates fatigue damage, but the surface rumpling results from the crack propagating underneath the surface.

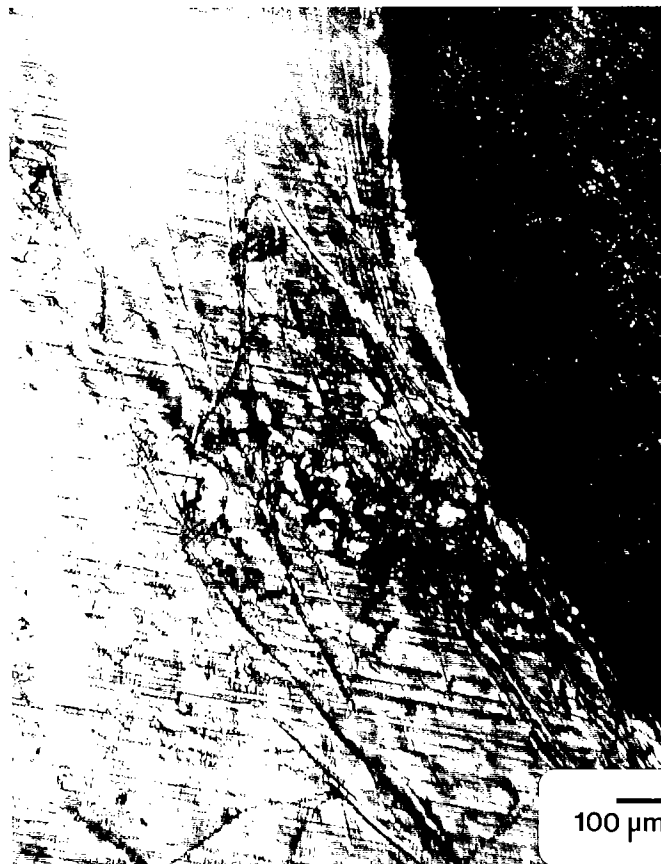
Fig. 4.7. Photomicrograph of a radial crack emerging from microcracks. (120,000 cycles)

the riveted specimen with a 40 times magnification optical microscope that was mounted to the MTS machine. On cycling, the first indication of fatigue damage was a rumpled region that consists of slip steps and microcracks. The microcracks were approximately 100 to 200 microns in length when the rumpled region was first observed. These microcracks were near the rivet head and were wiggly and in various directions with respect to the applied stress. The dominant cracks in the plates were at angles that were not normal to the loading direction. The cracks became normal to the loading direction on growth. This indicates combined tensile and shear mode fracture occurred until the crack propagation became normal to the loading direction. Typical microcracks are shown in the photomicrograph in Figure 4.6. Rumpling was first noticed at 175,000 cycles. This photomicrograph was taken at 215,000 cycles. A portion of the rivet head is seen in the upper left corner. The machining marks (large radius) are very superficial. A typical crack with the specimen loaded at a maximum nominal stress of 103 MPa is shown in the photomicrograph in Figure 4.7. These radial cracks form at the lower edge of the rivet head similar to the sketch in Figure 3.6.

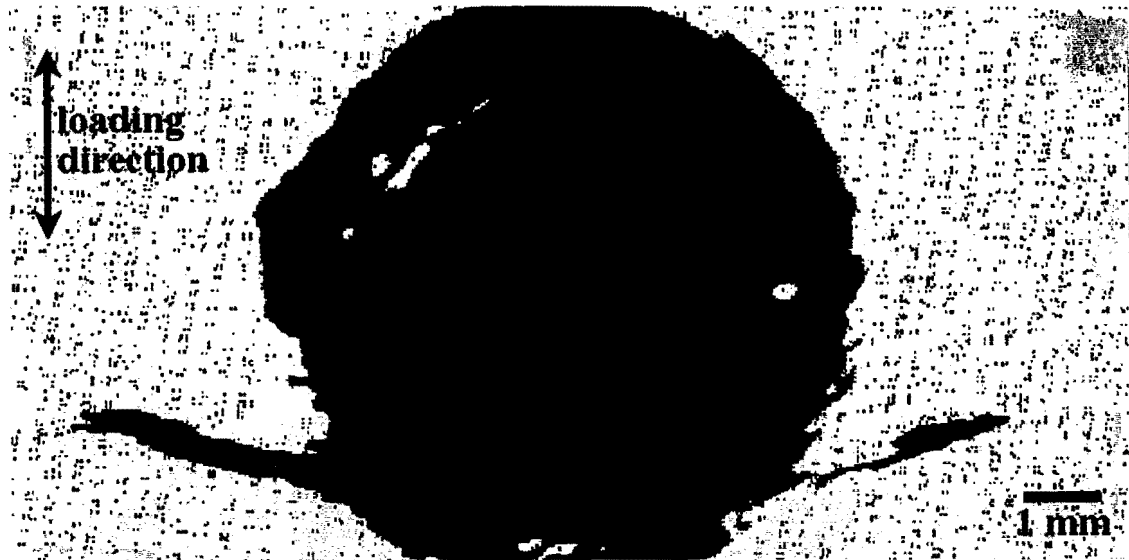
Fig. 4.10. Scanning acoustic microscope C-scan image of a specimen showing a well developed eyebrow crack at an angle of about 20° to the stress axis normal (200,000 cycles).

Figure 4.10 is an example of a C-scan image of a specimen with a fully developed eyebrow crack on each side of the rivet. The end-to-end crack length is ca. 12 mm. Figure 4.11 is an example of a C-scan image of a specimen with the eyebrow crack detected only on one side. Figure 4.12a is another example of cracks on both sides of the rivet. This specimen was cycled for 220,000 times and the cracks are 4.8 mm and 1.5 mm long in the C-scan image giving an end-to-end crack length also of 12 mm. Optically measured, these cracks were smaller, 3.9 mm and 1.1 mm. Figures 4.12b and 4.12c are optical micrographs of the left and right side of the areas of the specimen in which the cracks occurred, respectively. Figure 4.12b clearly shows the

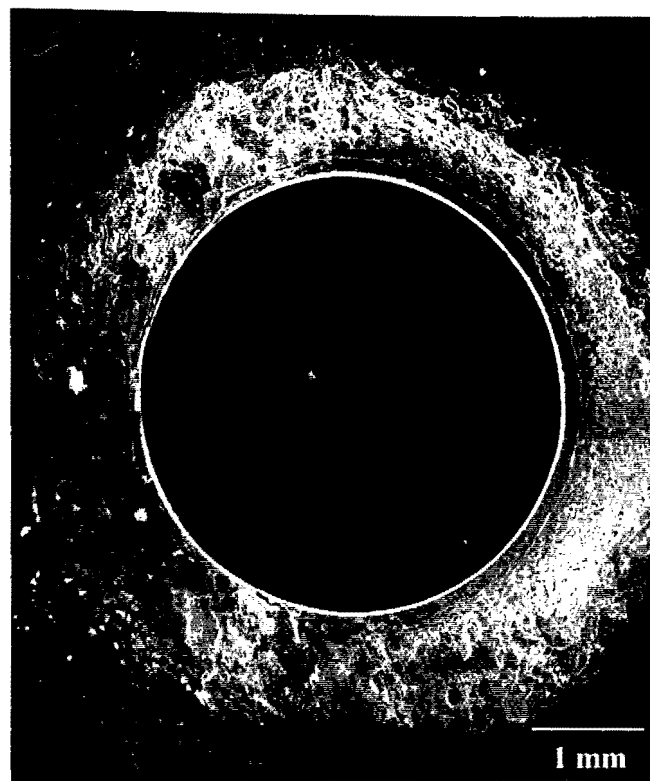
Fig. 4.14. Micrograph of the damaged surface of a specimen fatigued at a maximum nominal applied stress of 103 MPa. (205,000 cycles)

Figure 4.14 is a micrograph of the damaged fayed surface of a specimen that was fatigued for 205,000 cycles at a maximum nominal applied stress of 103 MPa. This damage occurred during the fatigue cycling. Note that the area in the figure around the entire rivet shows damage.

different levels of stress. At 103 MPa, a great deal of fretting damage is seen around the entire rivet hole (Figure 4.14) while little fretting damage is seen around the bottom of the rivet hole at 154 MPa (Figure 4.33b) When fretting occurs around the entire rivet hole, this indicates fretting is the primary cause of fatigue rather than the stress concentration at the hole. [Forsyth, 1981] At the higher stress of 154 MPa, crack nucleation results *primarily* due to the stress intensity factor at the centerline of the rivet hole.

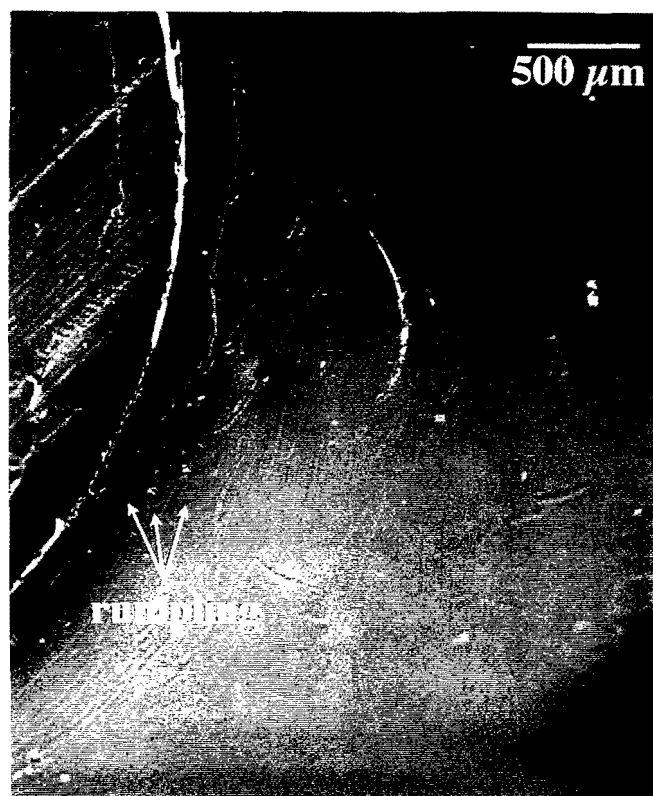
Fig. 4.16. Scanning electron micrograph of replica of the same specimen shown in Figure 4.15 but taken at 195,000 cycles and showing surface rumpling in the area indicated by the arrows.

The number of cycles between the first observance of a crack on the acoustic scans and the observance of surface rumpling as seen when viewing the replica using the SEM was 55,000 cycles in a specimen where the two were compared. A crack on the right side was first observed in the acoustic C-scan at 140,000 cycles shown in Figure 4.15. Faint surface rumpling from this crack was first observed at 195,000 cycles and is shown in the scanning electron micrograph of the replica in Figure 4.16. Figure 4.17 is the C-scan of the specimen at 195,000 cycles. In some of the earlier scans of this specimen, there is possible evidence of two cracks on the left side, which are growing together.

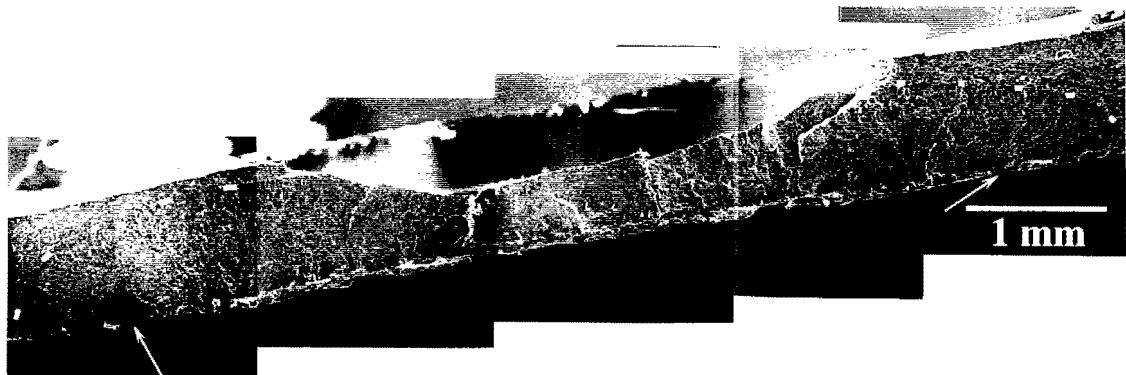
Fig. 4.18. Scanning electron micrograph of the top fracture surface of the specimen shown in Figures 4.16 and 4.17 after 205,000 cycles. The end-to-end crack lengths are given by the plot in Figure 4.19.

To determine the initiation sites of cracks and other crack characteristics, the fracture surfaces of specimens were examined. The test of the previous paragraph was stopped after 205,000 cycles, and the specimen was disassembled by removing the rivets and separating the panels. The countersunk panel, which always contained the fatigue crack, was fractured in tension to reveal the fatigue fracture surfaces. A scanning electron micrograph of the fracture surface is shown in Figure 4.18. The fatigue crack surface is outlined by the dotted white line. Interestingly, when the

specimen was fractured, the fatigue crack was observed to be near the rivet hole but not through it. Cracks initiated on each side of the rivet, and as they grew they eventually linked up bypassing the rivet and hole. The initiation sites for the cracks were located on or very near the hidden surface some distance from the rivet hole. A large particle is observed on the left side and appears to be at or near one of the initiation sites. This will be discussed in more detail later. The crack path linking the cracks on each side of the rivet for this eyebrow crack, as already stated, was located a short distance below the rivet hole. It avoided the region of extensive plastic deformation in the countersunk panel formed by the cyclic load transfer between the rivet and the panel, a region of compressive residual stress. This is a *true* eyebrow crack.

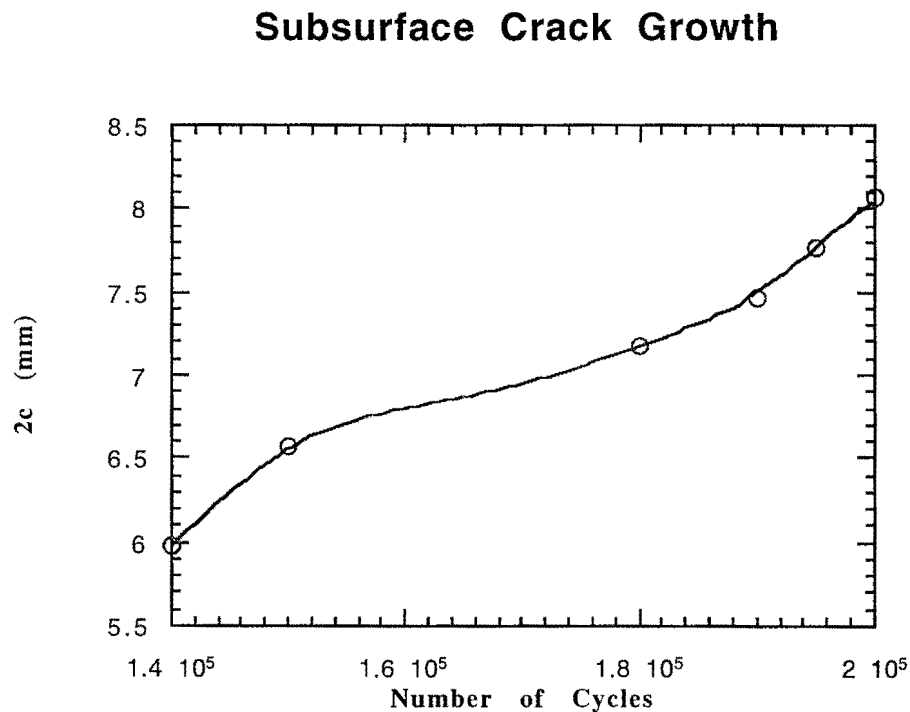
Fig. 4.19. Plot of end-to-end crack length vs. number of cycles for a subsurface crack as viewed in the acoustic C-scans. While a crack on one side was seen before 1.4×10^3 cycles, cracks on both sides were not seen before this examination of the specimen.

The crack length vs. cycle number as measured from the acoustic C-scans for this specimen is given in the plot in Figure 4.19. The average crack growth rate, $d(2c)/dN$, from 6 to 8 mm is approximately 5×10^{-5} mm per cycle. The SAM C-scan and the scanning electron micrograph of the fracture surface both showed the crack to be 8.1 mm in length. The crack was still not a surface breaking crack.

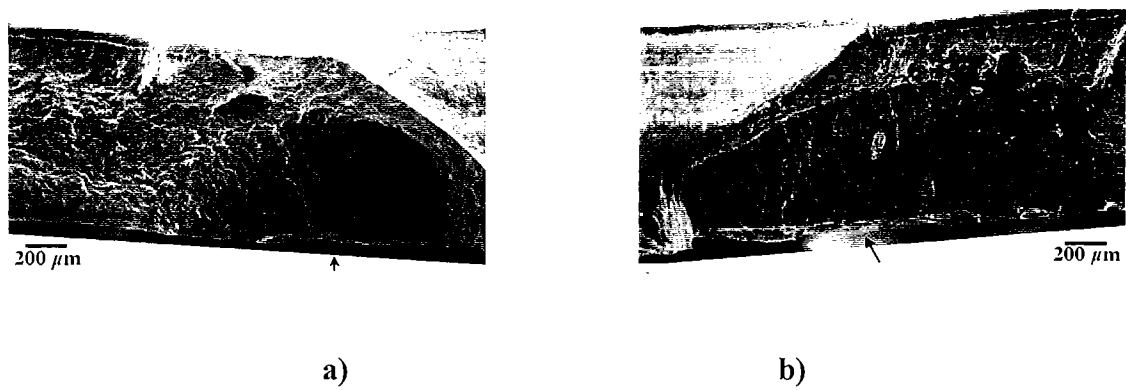
Fig. 4.21. a) Scanning electron micrograph of the bottom fracture surface showing the crack that corresponds to the crack shown on the right side of the acoustic scan in Figure 4.20.

b) Scanning electron micrograph of the bottom fracture surface showing the crack that corresponds to the crack shown on the left side of the acoustic scan in Figure 4.20.

specimen was then pulled apart, and scanning electron micrographs of the crack on each side of the rivet hole are shown in Figure 4.21. The arrows in the micrographs point to crack initiation sites, which again are some distance from the rivet hole. From these micrographs, it can again be seen that the crack has not yet reached the surface of the panel and additionally has not yet reached the rivet hole. Figure 4.22 is a micrograph of the fracture surface of this specimen in which the arrows indicate the boundary between the fatigue crack region in which radial markings pointing to the initiation site are seen and the ductile fracture region. The latter fracture occurred when the panel was pulled apart in tension to reveal the fatigue fracture surface. In the ductile part of the fracture, microvoids form at inclusions in commercial alloys such as the 2024 T3 used in this research. The microvoids then grow and coalesce to result in the ductile fracture. The microvoids make the surface look dimpled. Void-initiating particles can be seen at the bottom of some of the microvoids.

The multiple cracks that had initiated grew laterally and outward from the initiation sites and eventually would have linked up to form single cracks such as the ones shown in Figure 4.21. Growth normal to the hidden surface of the panel is slower; the crack shape is semi-elliptical. Note that the cracks on each side of the rivet in Figure 4.24 have not linked up in the interior of the panel and the crack front is cusp-shaped. Initial formation of many cracks and emergence of a dominant crack by faster growth and coalescence with other cracks is often observed in fatigue failures.

The initiation sites for specimens fatigued at a maximum applied stress of 103 MPa, as already noted, are located some distance from the blunt knife portion of the rivet hole. (Figures 4.21 and 4.24) When cracks nucleate away from rivet holes in lap joints, this is an indication that they were likely caused by fretting (Forsyth, 1981; Beard, 1988; Hoeppner, 1994; Müller, 1995; Fawaz, 1997) as opposed to cracks initiating at the centerline of the rivet hole as is expected since this is where the stress intensity factor is the greatest for a countersunk hole. In results reported by Piascik et al. (1997), fretting was the major cause of crack nucleation in tests performed on a full-scale fuselage. There was a correlation between the degree of fretting and cracking.

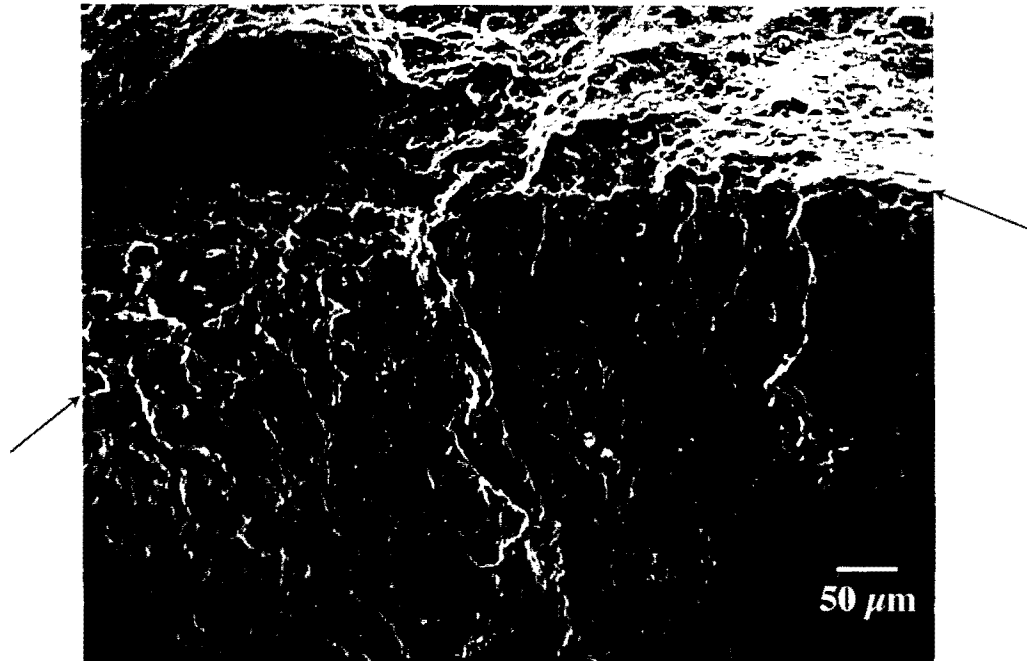
Fig. 4.22. Micrograph of the fracture surface of a specimen with arrows indicating the boundary between the fatigue crack and the dimpled ductile fracture resulting from pulling the specimen apart. (240,000 cycles)
